## GB Boiler – Frost Damage Flow Chart

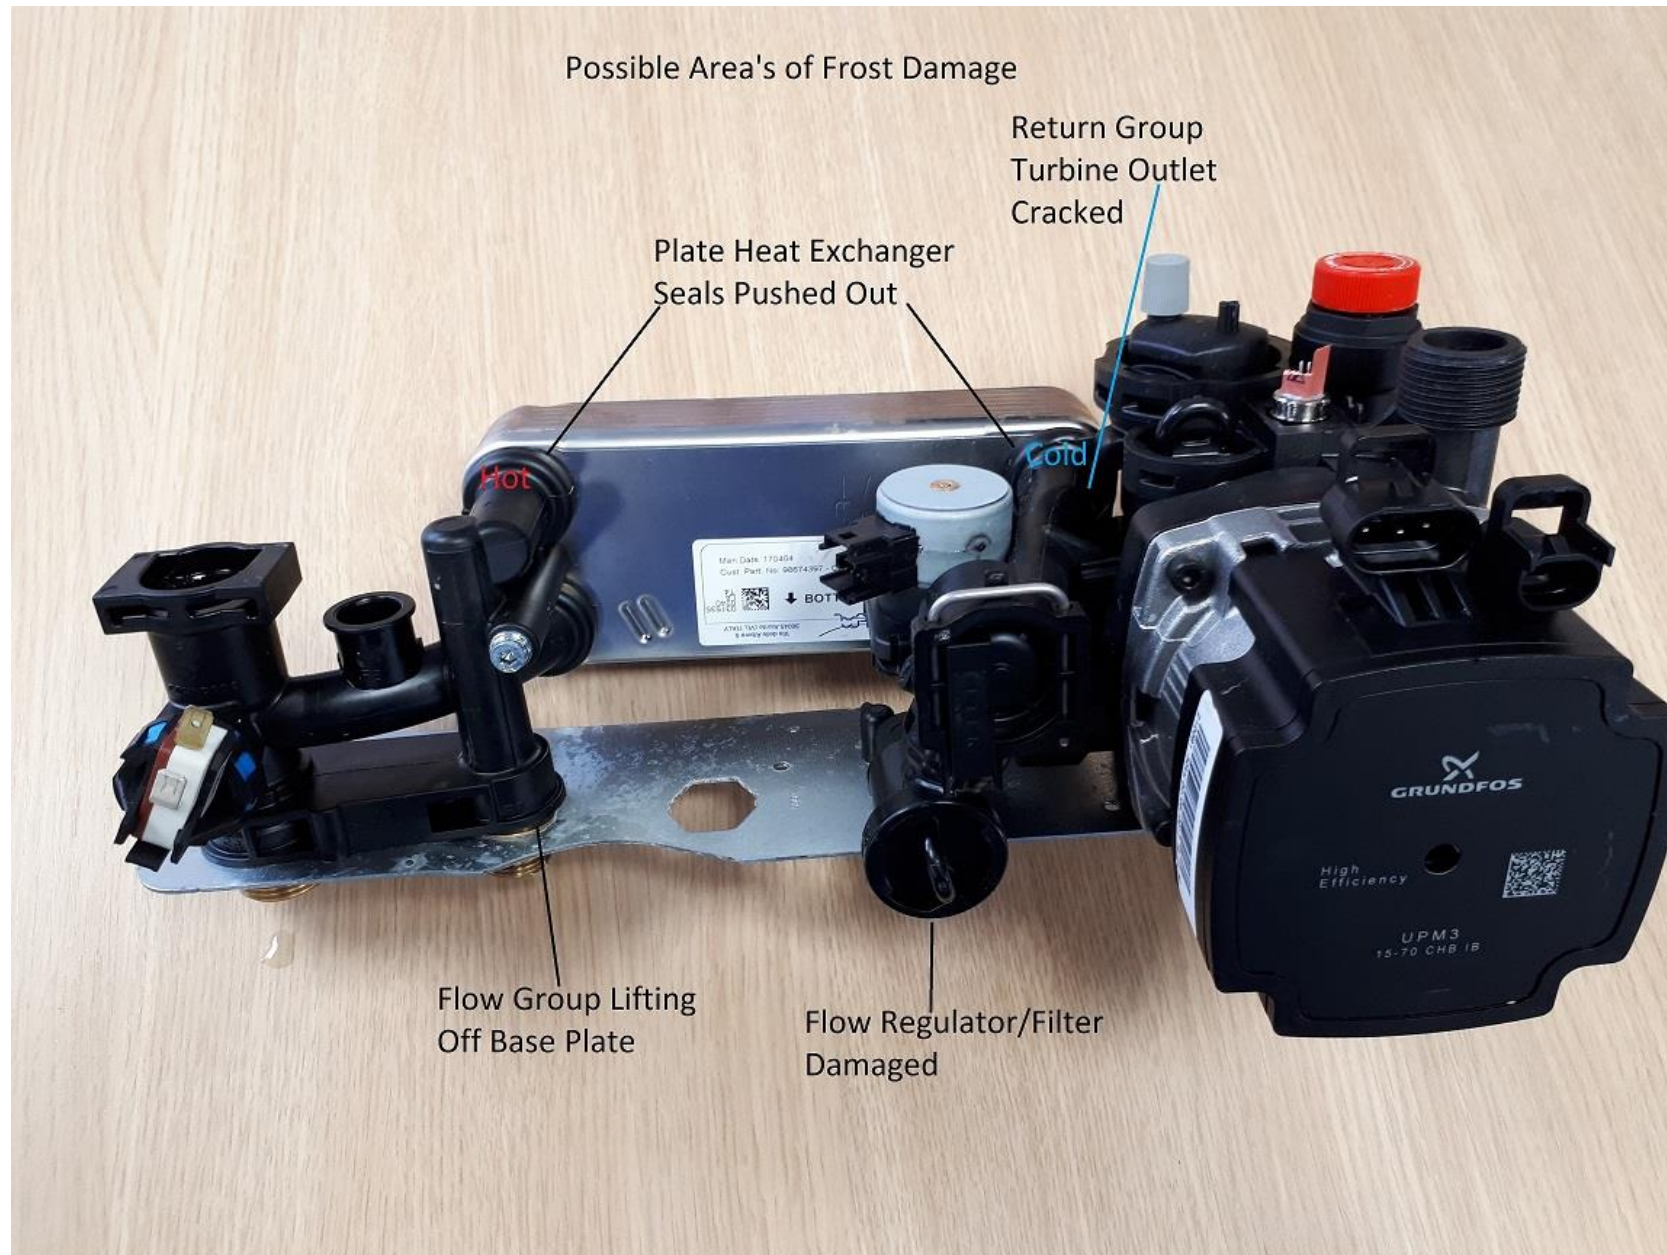
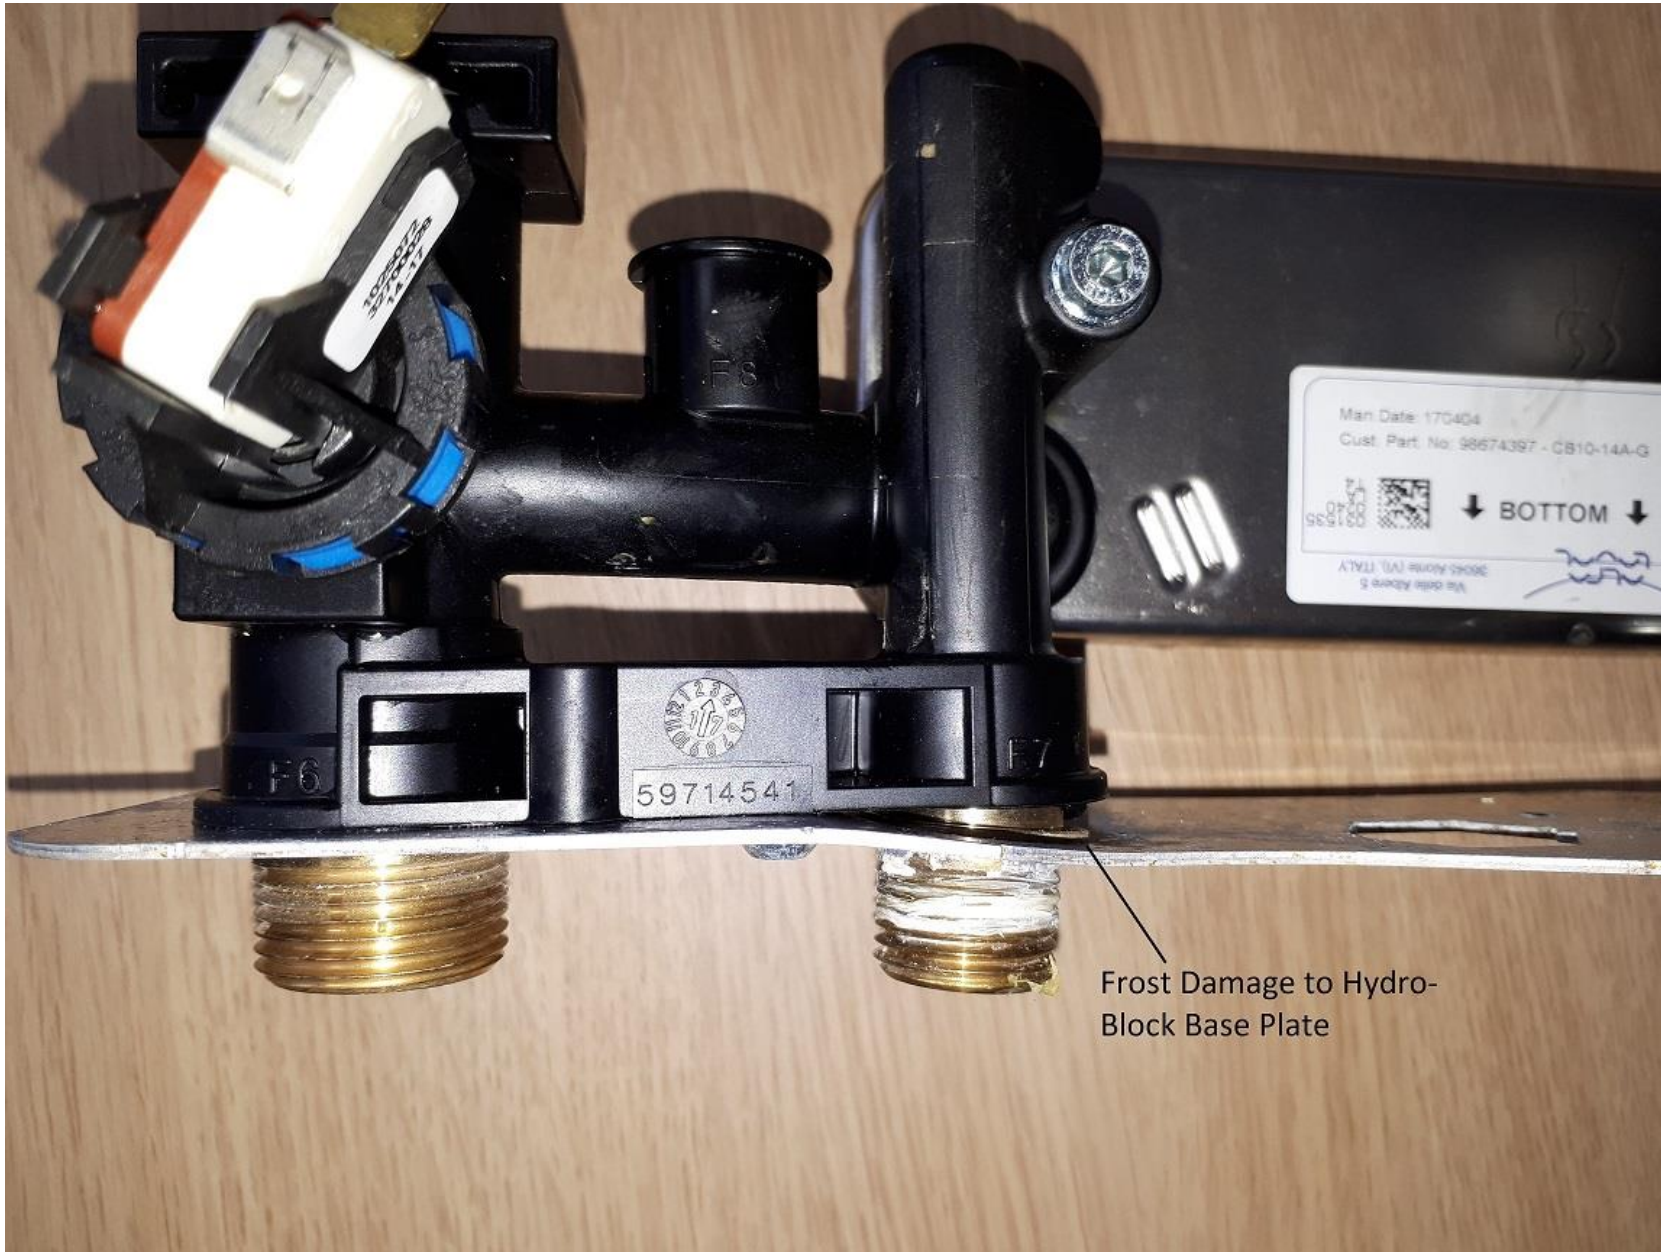
Frost Damage to Hydro-Block Base Plate

Morco have assessed a number of damaged hydroblocks and established that currently there are 4 main areas of frost damage. Please see the photos below. If an engineer is unsure as to which areas are broken and cannot identify them, the only way to guarantee a successful repair is to replace the entire hydroblock. Refurbishment can subsequently be carried out on the replaced hydroblock using the return group, flow group and heat exchanger kits. The hydroblock can then be used again.

If the base plate is damaged as shown above, then it may be impossible to straighten out and Morco do not supply it as a spare part. A new hydroblock is the only solution.

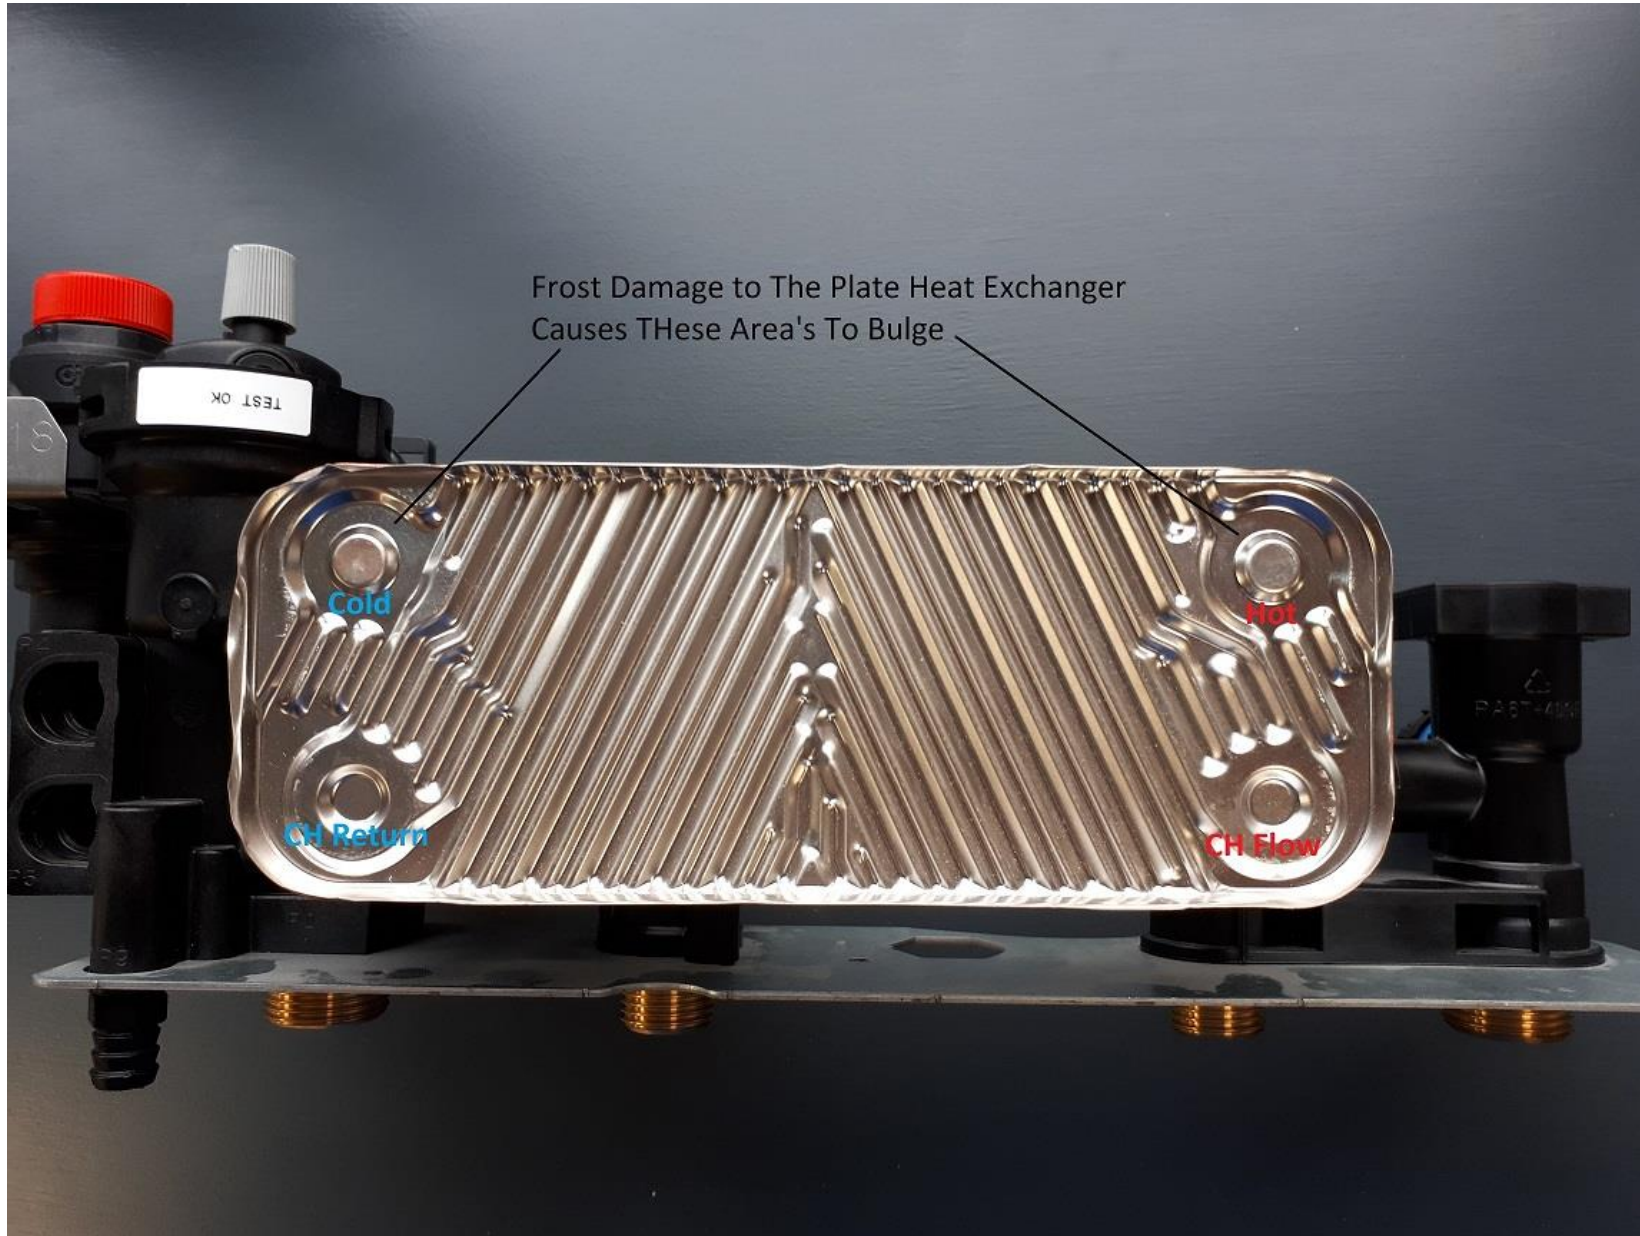
If there is any distortion in the areas labelled above then it can be safely assumed that there is internal damage. This will result in the internal waterways for the primary circuit being narrowed or blocked and will give problems with the safe and efficient operation of the boiler. It is entirely possible that, even without external distortion, that there is internal damage. Morco do not supply the specialised lip washers separately.

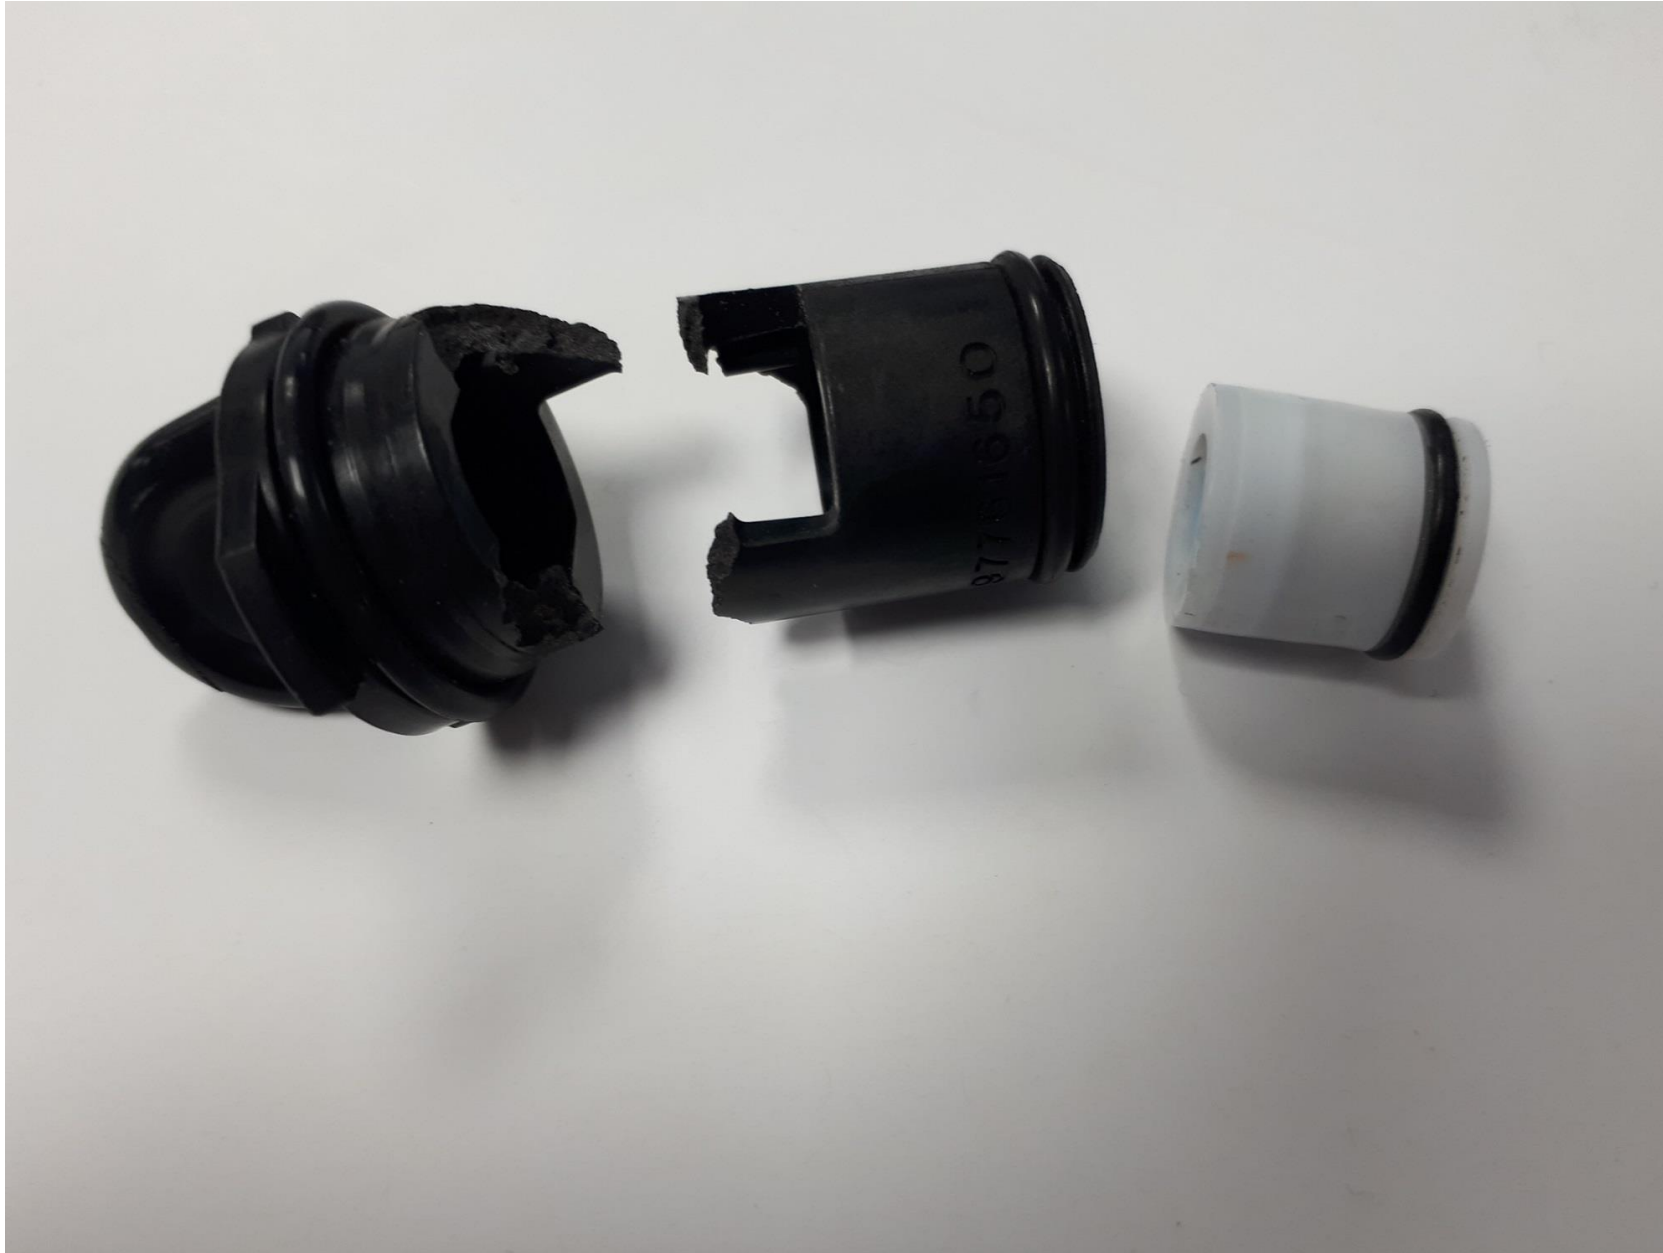
This shows the damage caused to the flow regulator/cold water filter.

If an engineer is absolutely sure he knows which components are damaged then the following sets are listed:

- ICB119001 – Return Group Kit (GB24 and GB30)
- ICB120001 – Flow Group Kit (GB24 and GB30)
- ICB121002 – Heat Exchanger Kit (GB24 only)
- ICB121302 – Heat Exchanger Kit (GB30 only)
