GB Boiler – Frost Damage Flow Chart

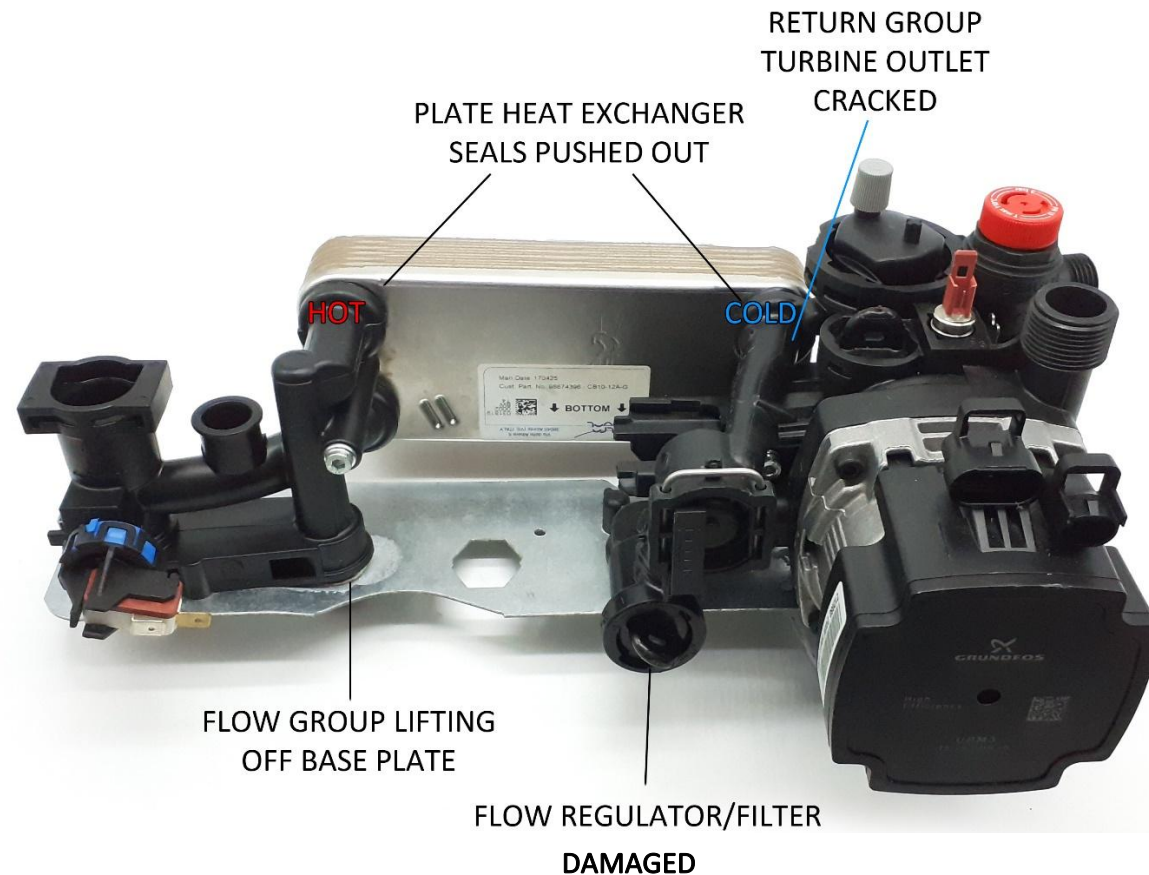
POSSIBLE AREAS OF FROST DAMAGE

Morco have assessed a number of damaged hydroblocks and established that currently there are 4 main areas of frost damage. Please see the photos below. If an engineer is unsure as to which areas are broken and cannot identify them, the only way to guarantee a successful repair is to replace the entire hydroblock. Refurbishment can subsequently be carried out on the replaced hydroblock using the return group, flow group and heat exchanger kits. The hydroblock can then be used again.

- [ICB132001 – Hydroblock 24kw](#) AAZ & ACH
- [ICB132002E – Hydroblock 24kw](#) ADP, ADH & ADM
- [ICB132003 – Hydroblock 24kw](#) AFN, AGY & AHN

- [ICB132300 – Hydroblock 30kw](#) AAZ & ACH
- [ICB132302E – Hydroblock 30kw](#) ADP, ADH & ADM
- [ICB132303 – Hydroblock 30kw](#) AFN, AGY & AHN

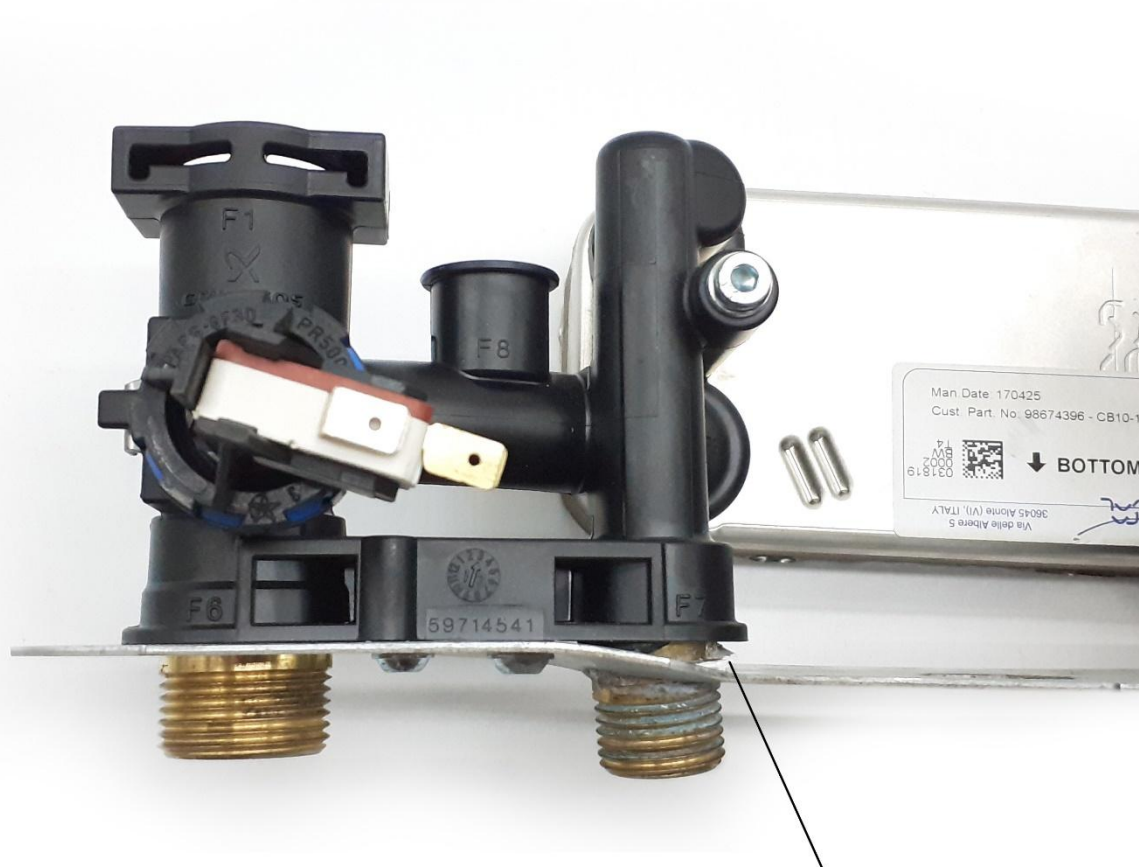
FROST DAMAGE TO
HYDROBLOCK
BASE PLATE

If the base plate is damaged as shown above, then it may be impossible to straighten out and Morco do not supply it as a spare part. A new hydroblock is the only solution.

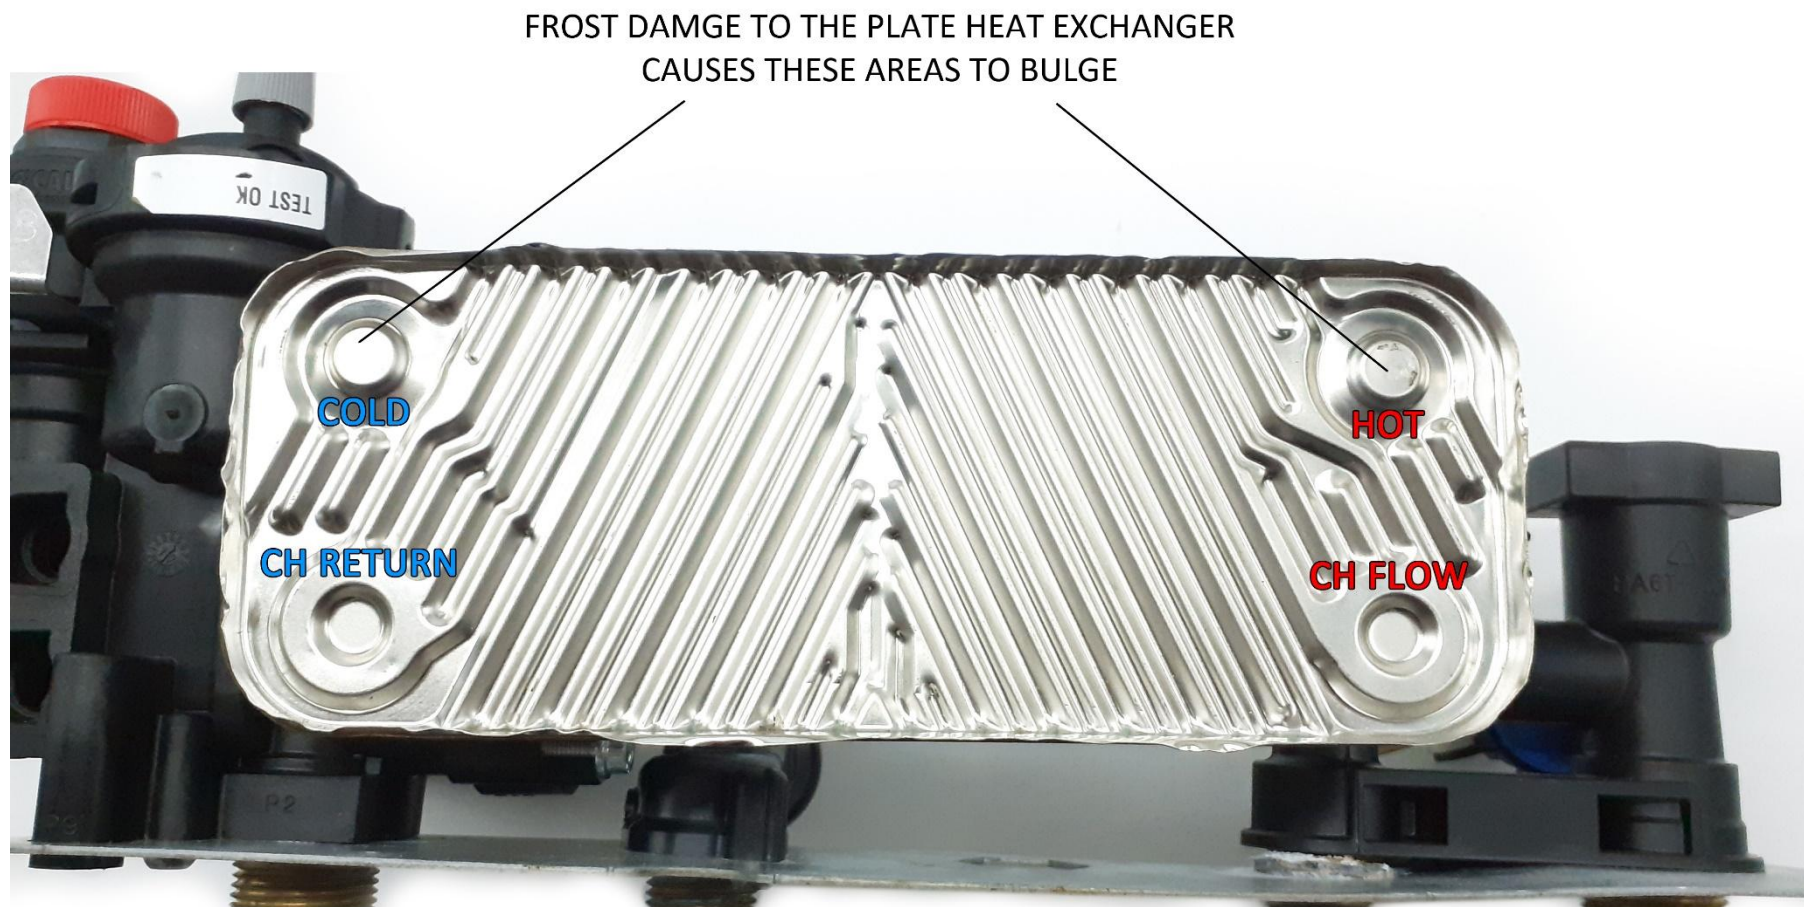
If there is any distortion in the areas labelled above then it can be safely assumed that there is internal damage. This will result in the internal waterways for the primary circuit being narrowed or blocked and will give problems with the safe and efficient operation of the boiler. It is entirely possible that, even without external distortion, that there is internal damage. Morco do not supply the specialised lip washers separately.

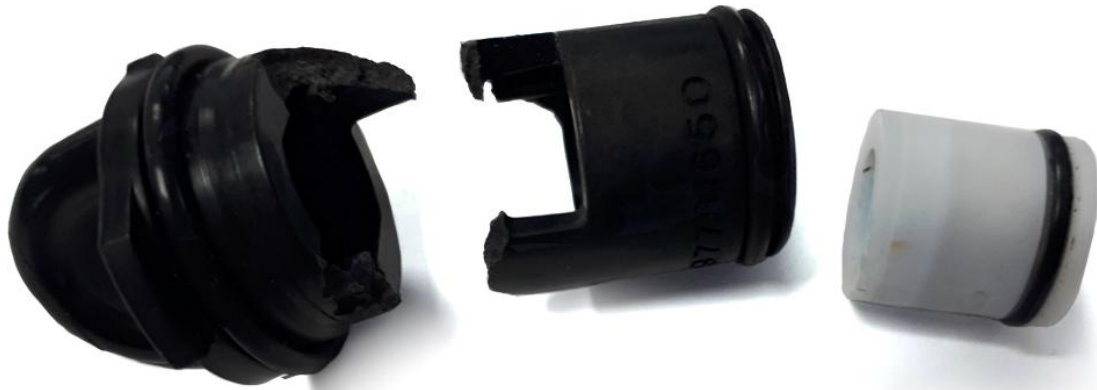
This shows the damage caused to the flow regulator/cold water filter.

- [ICB124001 – Flow Regulator 24kw](#)
- [ICB124300 – Flow Regulator 30kw](#)
