## GB Boiler – Frost Damage Flow Chart

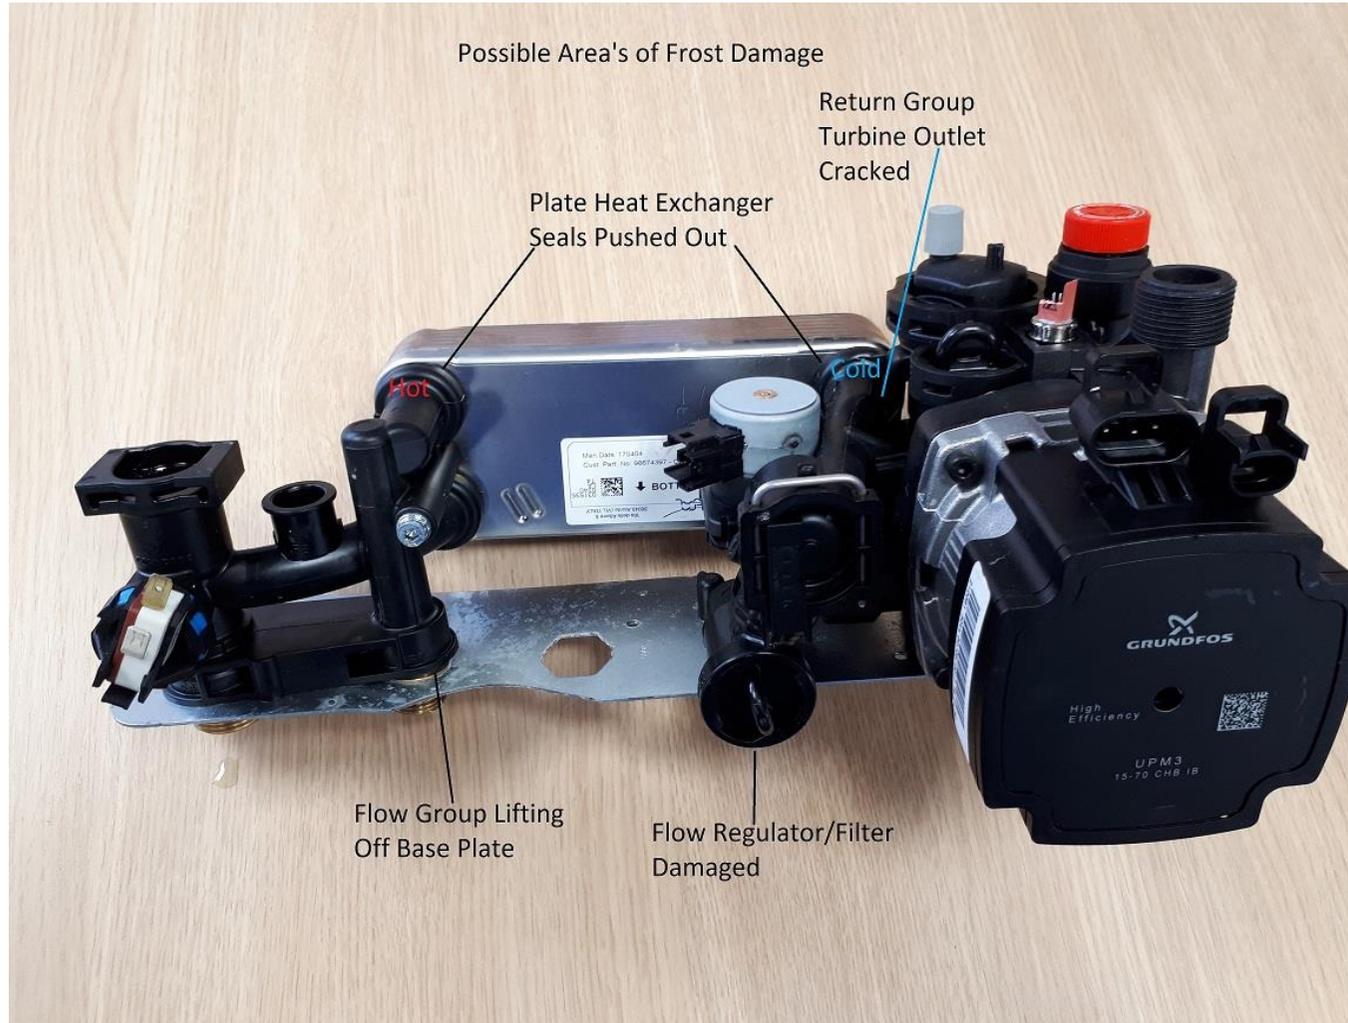
Morco have assessed a number of damaged hydroblocks and established that currently there are 4 main areas of frost damage. Please see the photos below. If an engineer is unsure as to which areas are broken and cannot identify them, the only way to guarantee a successful repair is to replace the entire hydroblock. Refurbishment can subsequently be carried out on the replaced hydroblock using the return group, flow group and heat exchanger kits. The hydroblock can then be used again.

**Please note the below photo may not reflect yours exactly if you have a boiler with s/n beginning AFN**

- [ICB132001 – Hydroblock 24kw](#) AAZ & ACH
- [ICB132002E – Hydroblock 24kw](#) ADP, ADH & ADM
- [ICB132003 – Hydroblock 24kw](#) AFN

- [ICB132300 – Hydroblock 30kw](#) AAZ & ACH
- [ICB132302E – Hydroblock 30kw](#) ADP, ADH & ADM
- [ICB132303 – Hydroblock 30kw](#) AFN

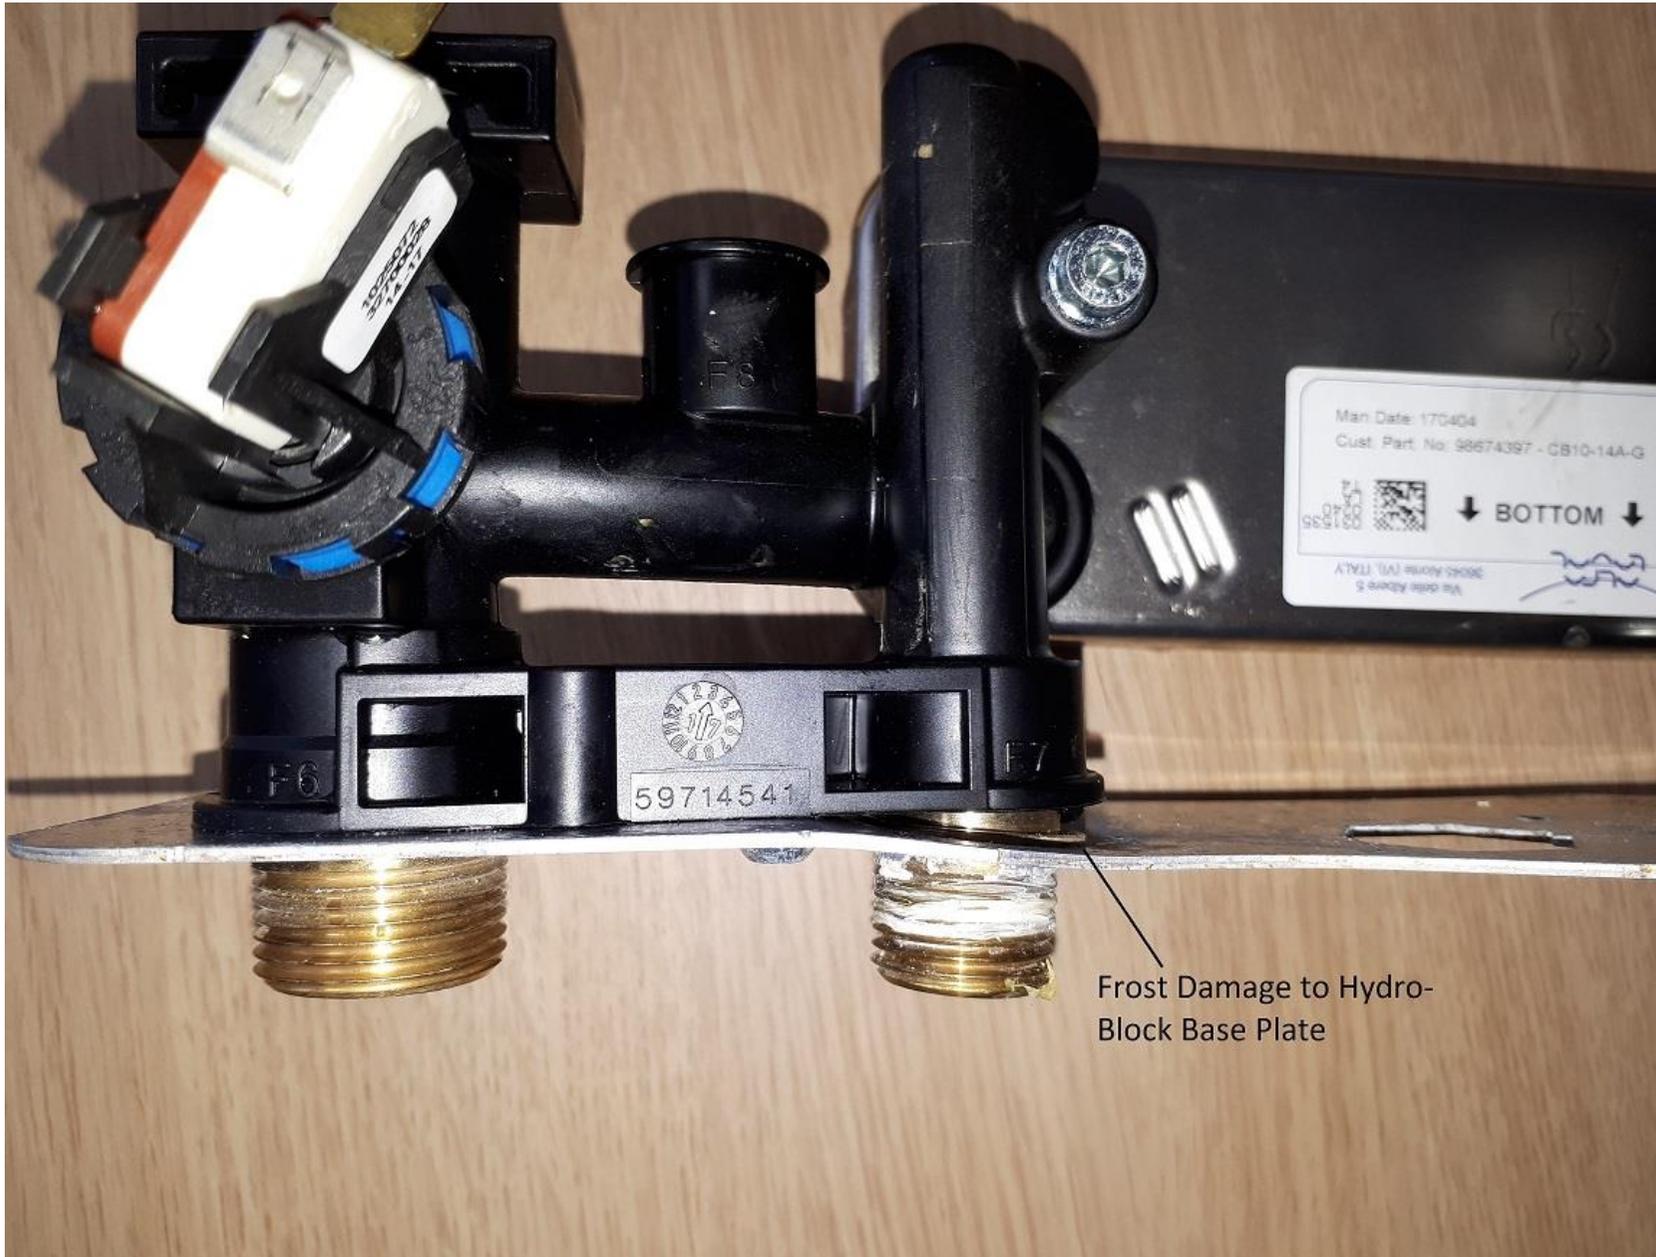
If the base plate is damaged as shown above, then it may be impossible to straighten out and Morco do not supply it as a spare part. A new hydroblock is the only solution.

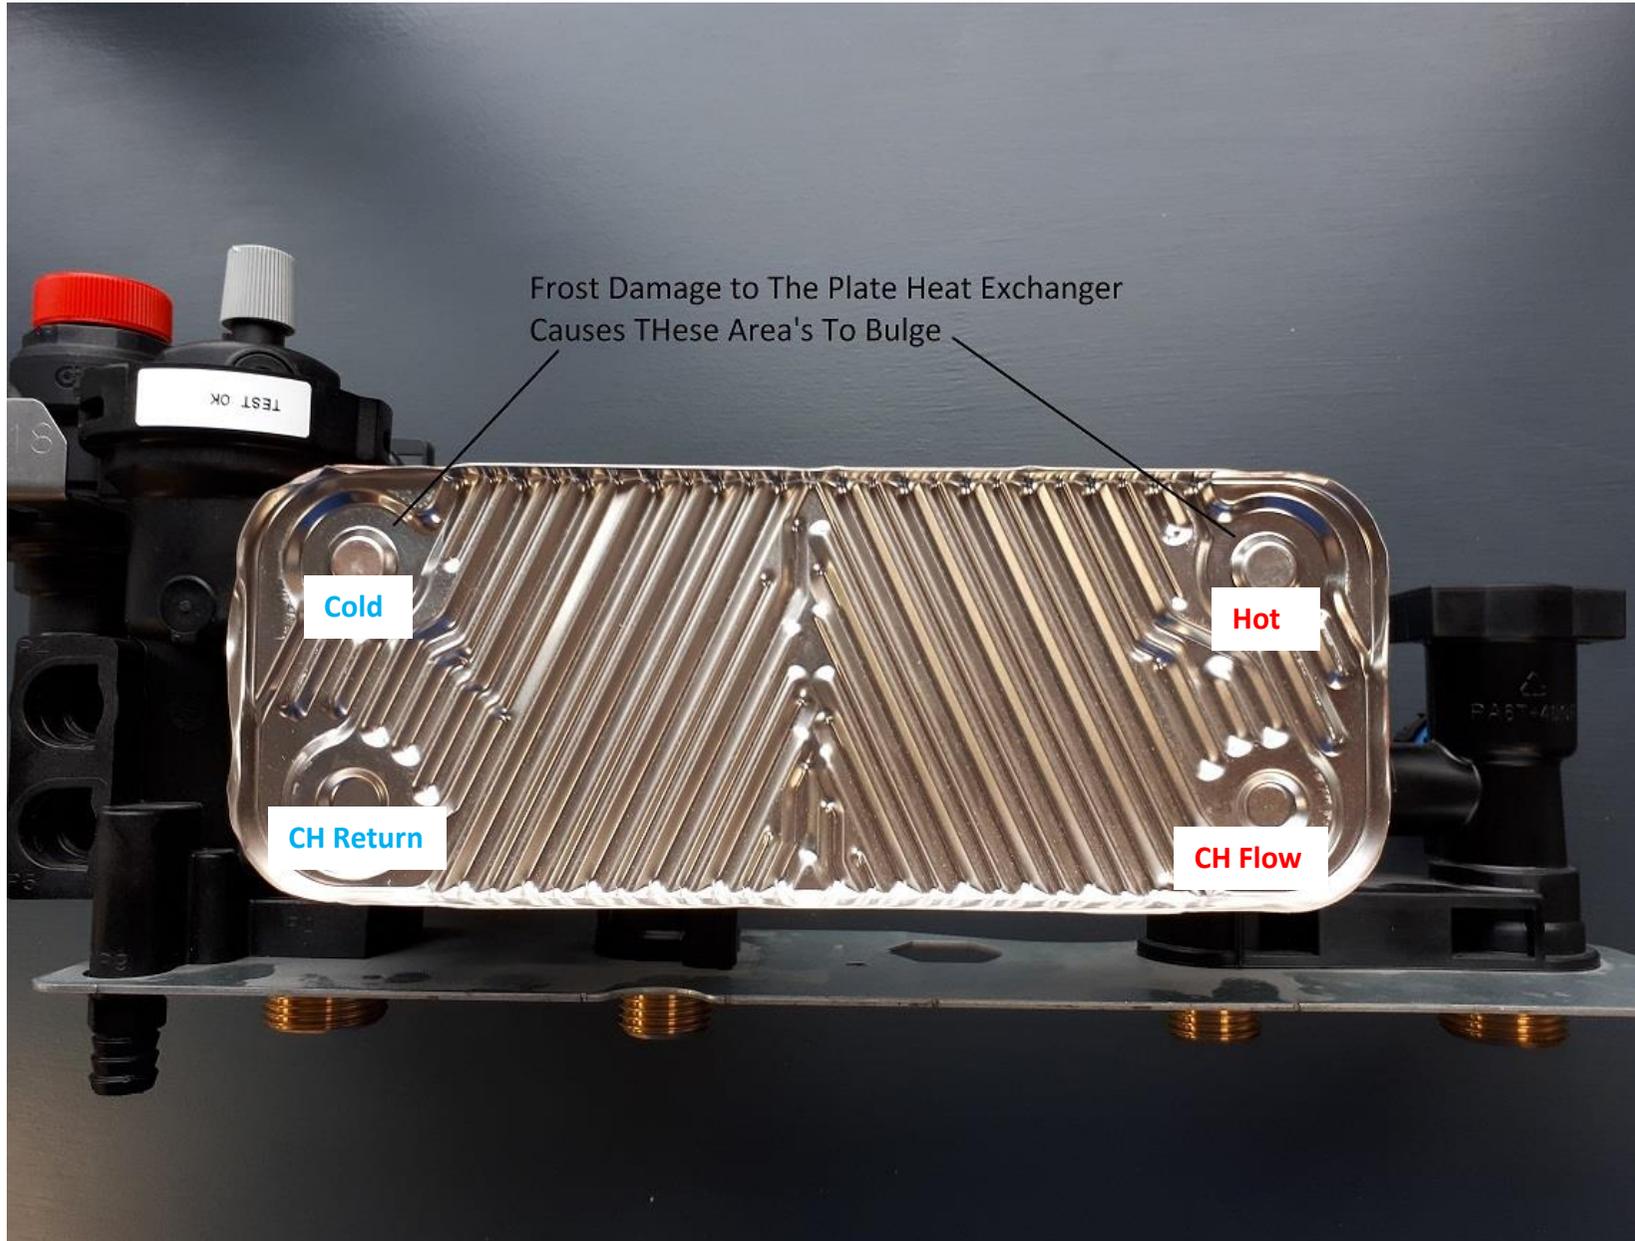
If there is any distortion in the areas labelled above then it can be safely assumed that there is internal damage. This will result in the internal waterways for the primary circuit being narrowed or blocked and will give problems with the safe and efficient operation of the boiler. It is entirely possible that, even without external distortion, that there is internal damage. Morco do not supply the specialised lip washers separately.

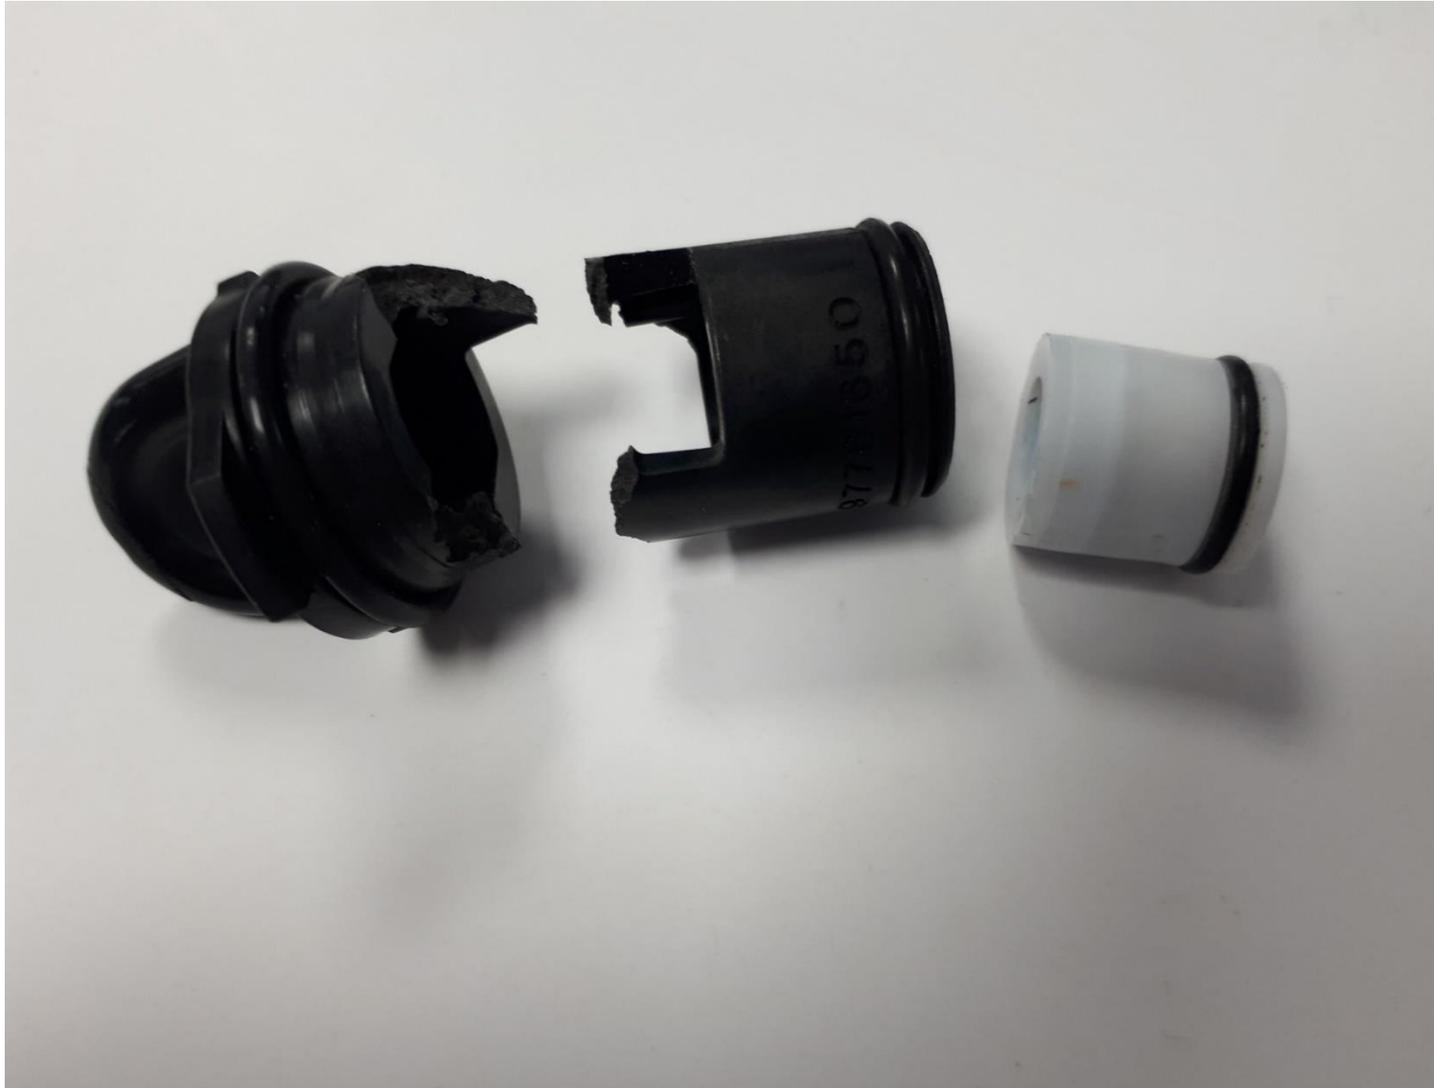
This shows the damage caused to the flow regulator/cold water filter.

- [ICB124001 – Flow Regulator 24kw](#)
- [ICB124300 – Flow Regulator 30kw](#)
