Winterisation of Holiday Homes

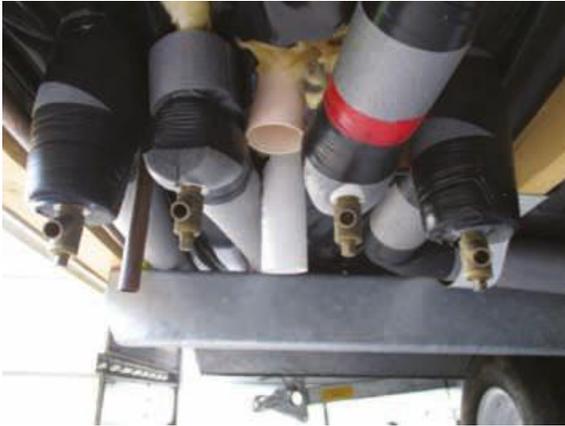
The above photo shows the plumbing under a home directly under a combination boiler. The two outer drain cocks are for the sealed central heating system and the two inner drain cocks are for the fresh water. Only open those for fresh water.

- Open all hot and cold taps and shower valves and place the shower head in the tray
- Use the Holiday Home Owner’s Handbook to locate the fresh water drain cocks under the van
- Open these drain cocks – if you have a centrally heated home DO NOT open all the drain cocks directly under the combination boiler as this will drain the sealed system and this should be protected by antifreeze – see details in “Additional Information for Combi Boilers”

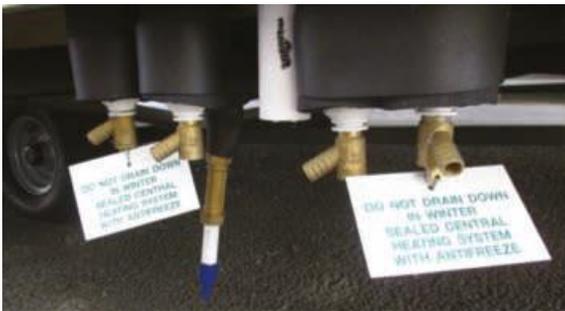
This manufacturer has helpfully labelled the central heating system drain cocks to avoid them being incorrectly used.

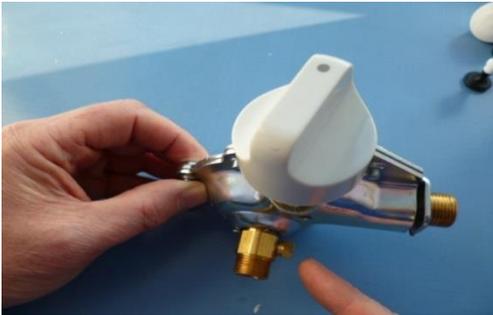
The finger is pointing at the drain plug in the brass body of the cold water inlet at the bottom of the boiler. This drain plug should be removed taking care to retrieve the plastic washer.

All Morco water heaters including the D51/61, G11E and F11E have a drain plug which is located at the bottom of the boiler and is shown in the pictures overleaf. This should be removed after all the drain down procedure has been carried out and the plug placed safe for use after the winter.

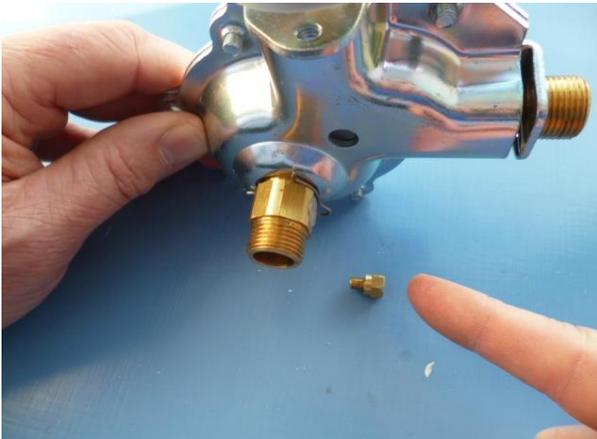
The drain plug has been removed but the washer is still adhered to the brass body.

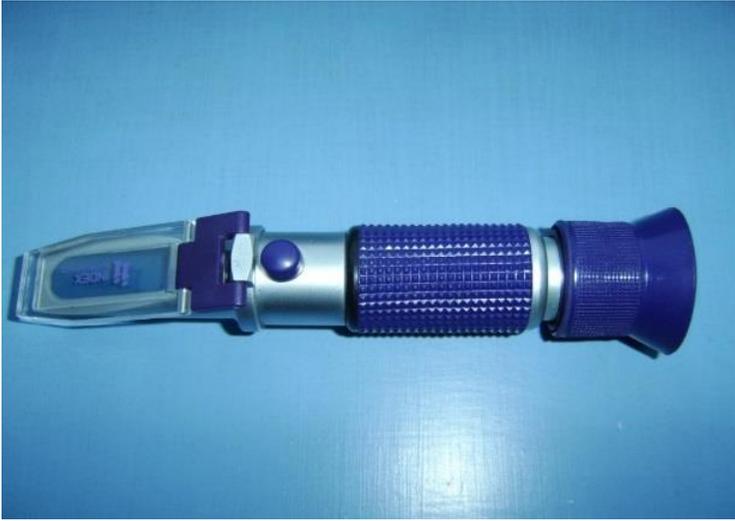
This is Morco's refractometer PPCRHA200ATC which can be purchased from our website for £46.50 plus VAT.

As part of the winterisation process an experienced engineer should use a refractometer (see below) to determine the level of protection. If it is too low, he will refill the sealed system to the required level.

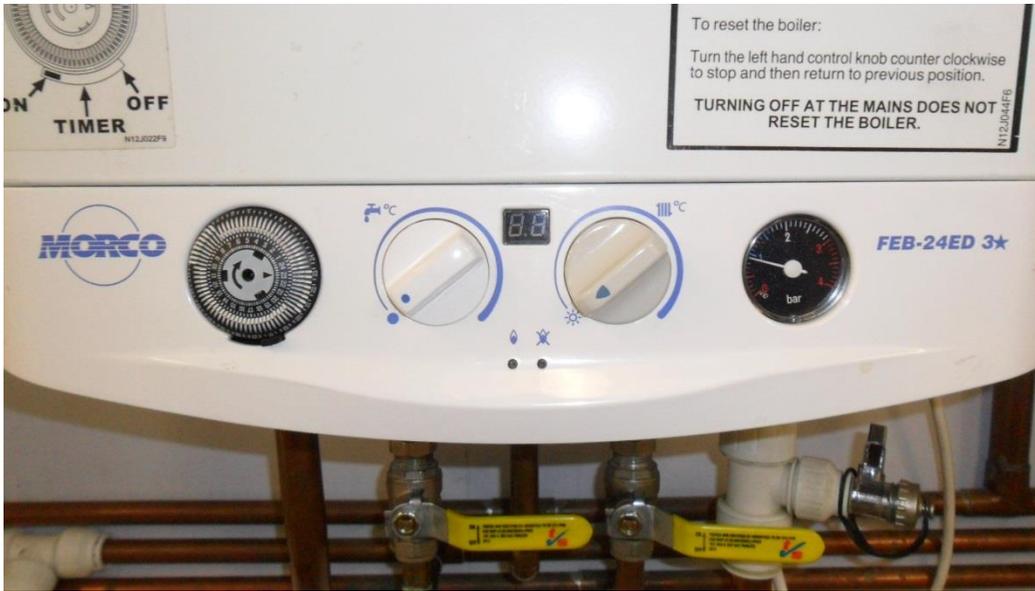
connected to a gas AND electric supply THROUGHOUT the winter and have the controls set to the correct position. Below is a photo of the correct position for the FEB24E, FEB24ED and FEB24ED3* boilers.

For Morco combination boilers the control knobs need setting to the off position which is fully anticlockwise*. If the boiler experiences any problems during the winter such as low system pressure or a component failure, the frost protection system will not operate. A frost protection system WILL NOT protect the fresh water circuit and will only give partial protection to the sealed circuit. For these reasons it should be used ONLY as a back up to a full drain down and an antifreeze check-up.

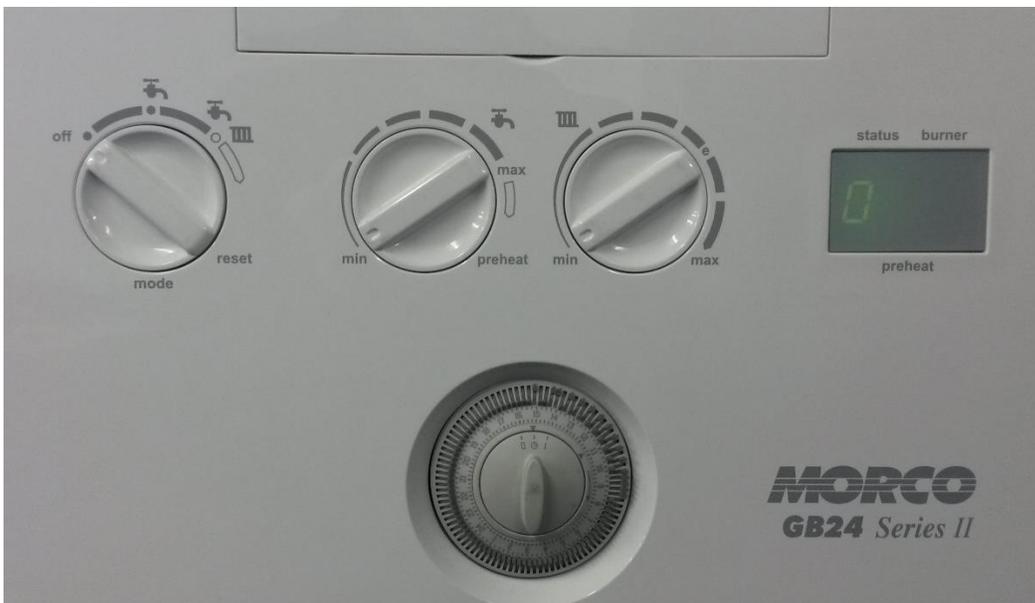
Below is a photo of the correct position for the GB24 and GB30 range of boilers.

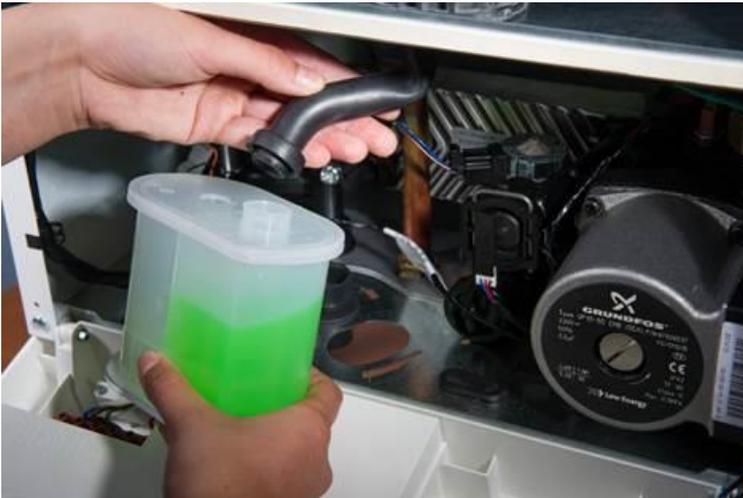
1. The condensate trap used should be siphonic. It will store approximately 150ml of warm condensate inside the boiler and release it all at once making freezing within the pipe below less likely. Morco's GB range of condensing boilers features a siphonic trap.
2. Condensate traps can be removed from the boiler when it is not in use to avoid being damaged by frost. They must be replaced prior to turning the boiler on as they are an important feature of the boiler's operation (see photo). The colour of the condensate is not green as in the photo but clear. The Morco trap in the GB24 boiler has been frost tested and has not failed so removing it is a belt and braces approach rather than a necessity.

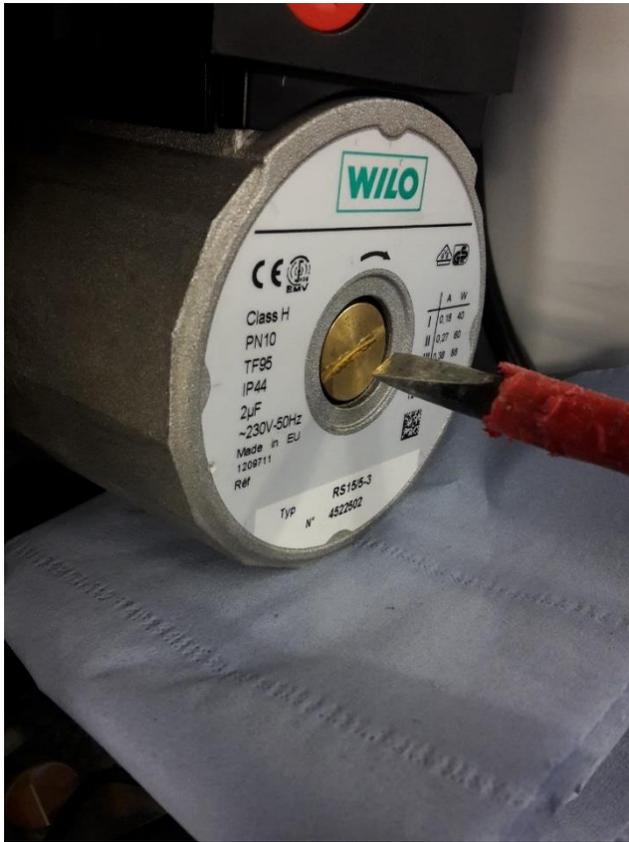
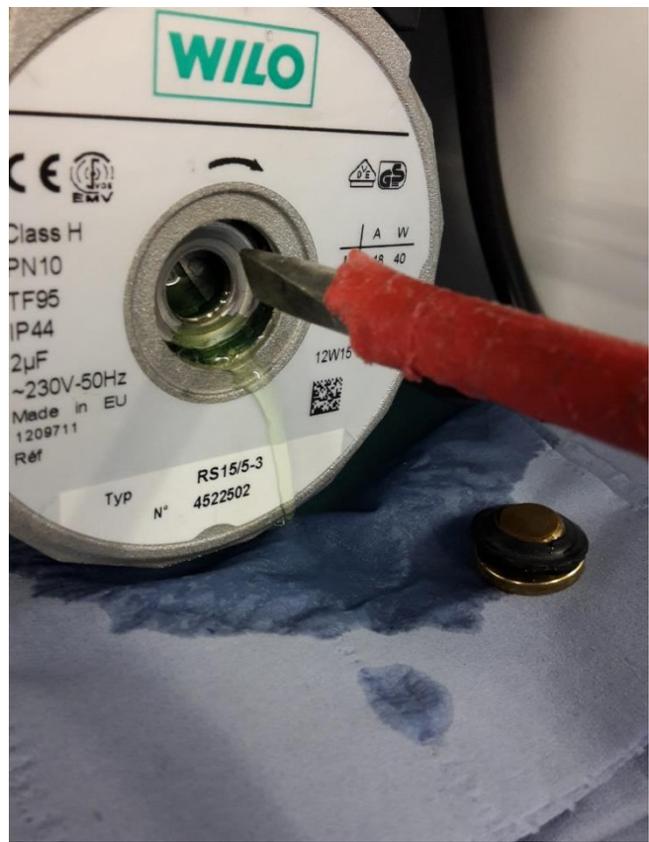
FEB24 Range

In the case of the earlier ranges of boilers you will first need to remove a blanking nut and a small amount of water may leak out so have a cloth placed underneath the pump as shown below. Either a flat bladed screwdriver or an allen key will be needed to turn the spindle.

- Turn the electric supply to the boiler off
- For the FEB24 range, prise off the boiler white front cover (it has 2 pop studs on each side) and drop the plastic lower panel by removing 2 cross head screws on the front of the panel and 2 on the underside. For the GB range the process is much simpler – there is a flap between the plastic lower cover and the metal cover – simply open the flap, undo the 2 cross head screws, clip the flap closed to retain the screws. The whole plastic cover will drop down on a hinge.
- Now the pump will be visible and you will need to insert a screwdriver into the front of the pump and turn a few times to free the pump spindle.

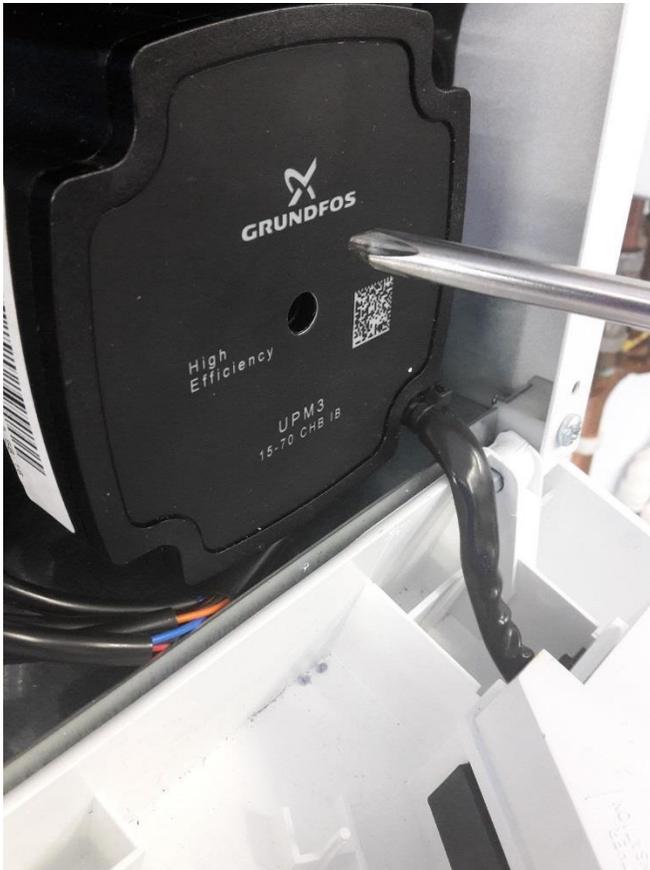
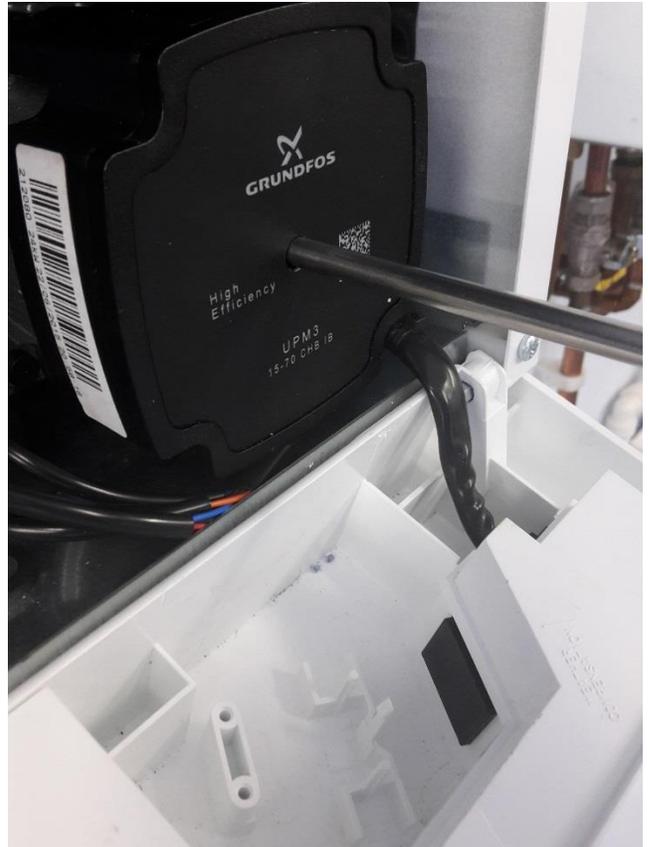
Later GB Series II

In the case of the later GB boilers this requires a Philips screwdriver and is easy as shown below:
