Low Central Heating System Pressure

Fault Code display and Pressure Gauges

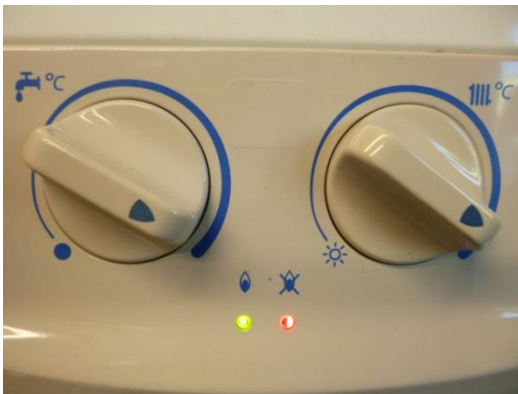
FEB20E and FEB24E Combi Boilers.

If there is low pressure in the sealed heating circuit then the gauge will show 0.7bar or below and the right hand LED (picture left) will flash on for 5 seconds and then two 1 second flashes followed by one 5 second flash.

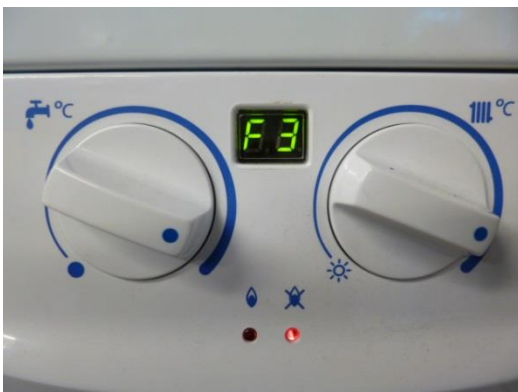
FEB24ED and FEB24ED 3*

If there is low pressure in the sealed heating circuit then the gauge will show 0.7bar or below and the display will show F3.

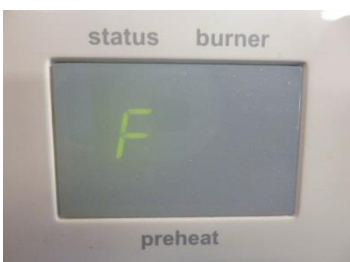
GB24 and GB30

If there is low pressure in the sealed heating circuit the gauge below the boiler will show 0.5 bar or less and the display will alternate between "F" and "1".

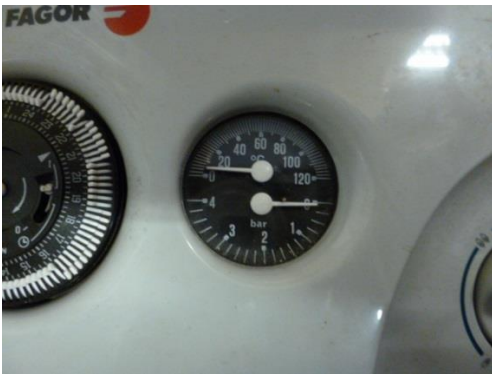
FEB20E – This gauge is a combined central heating system pressure and temperature gauge. The pressure gauge is on the bottom and this one is unpressurised and showing zero. This gauge should read 1.5bar when cold.

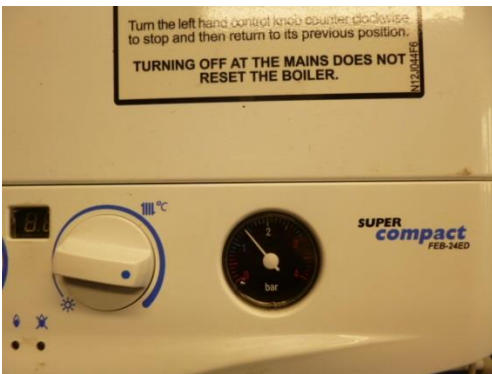
FEB24E, FEB24ED and FEB24ED3*

This gauge should read 1.5 bar when cold.

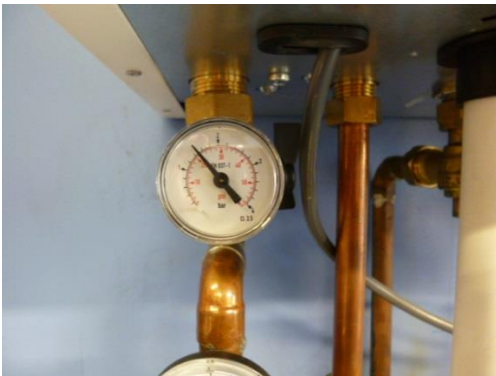
GB24 and GB30

This pressure gauge is connected to a pipe beneath the boiler on the left hand side. It should read 1.5 bar when the system is cold.

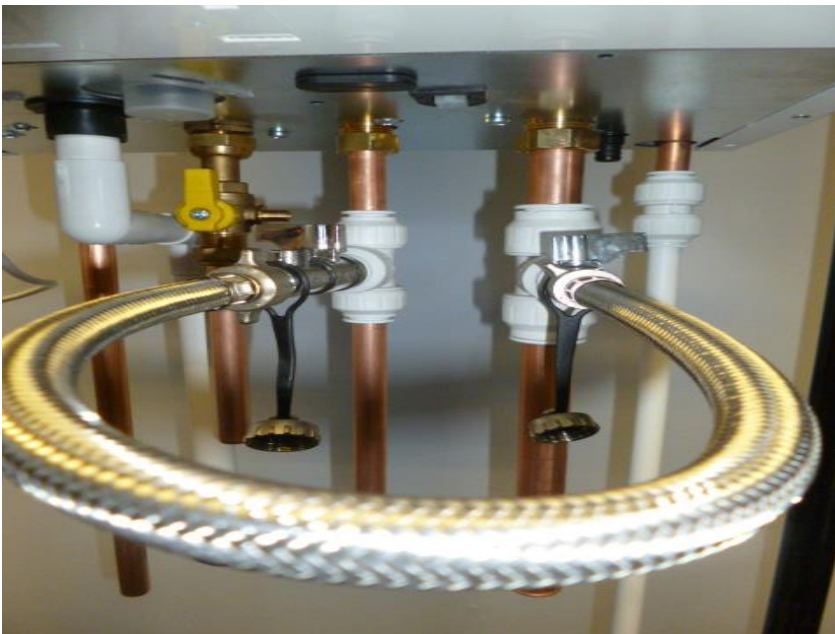
This procedure can easily be carried out by the home owner. The boiler is supplied with a filling loop (a 12inch/300mm long braided steel hose) that will either be fitted to the boiler or kept in a safe place such as a kitchen drawer. This hose connects the fresh water supply to the sealed central heating circuit. The hose should not be permanently connected as it is against the Water Regulatory Advisory Scheme guidelines (WRAS). Please see the photo below for a typical filling loop installation.

- Make sure the boiler is cold
- Carefully undo the blanking caps as the tap/taps may have been opened accidentally
- Attach the braided steel hose - this should be stored in one of the kitchen drawers or similar
- Make sure the hose is securely connected at both ends
- Open the black plastic tap very slowly and listen for the rush of water while watching the pressure gauge (on more recent installations there is a silver tap on either end of the filling loop)
- The gauge should increase slowly and just before it reaches 1.5bar turn the black plastic tap off
- Now remove the filling loop hose and store it safely - leaving it in position contravenes water bye laws and can result in a boiler becoming over pressured.
- Replace the blanking caps
- Turn the heating system on and watch the gauge rise to a maximum pressure of 2.2-2.5bar

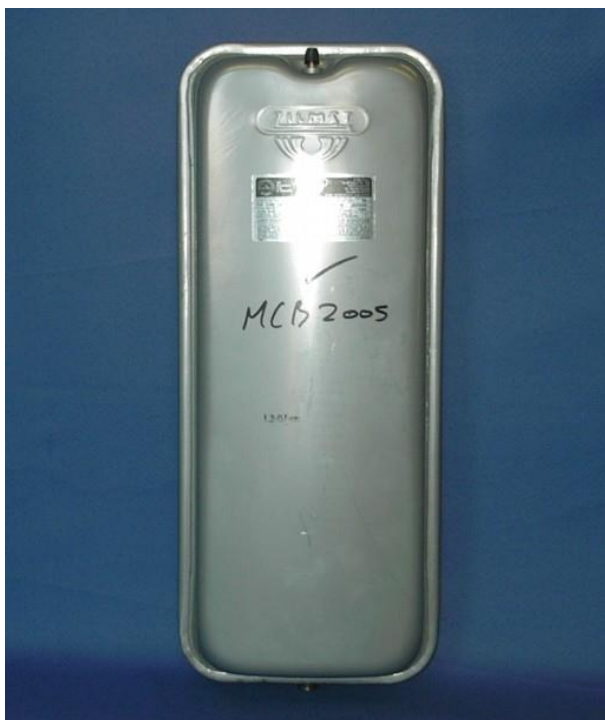
A typical expansion vessel with the “bicycle” valve at the top and the 3/8 inch BSP connection to the sealed system just visible at the bottom.

All combi boilers have expansion vessels. These allow the fluid (a mixture of water, antifreeze and corrosion inhibitor) in the sealed central heating system to expand as it heats up. The expansion vessel is best thought of as a “balloon” in a steel tank. The balloon is pressurised via a valve on the side of the tank and the sealed heating fluid fills the rest of the tank. As the fluid in the sealed system expands it compresses the balloon allowing the pressure within the system to remain under 2.5bar. The hotter the water gets the more the fluid expands and the more the balloon is compressed. If the balloon is punctured or the air pressure within the balloon is below 1 bar, the immediate effect is to increase the heating system pressure as shown on the boiler pressure gauge. This may trigger a low pressure fault code once the system has cooled down. If the user tops up the system as in the above section, the space the air in the balloon used to occupy will now be taken by water. The air in the balloon leaves the system either via a faulty valve on the expansion vessel or via the automatic air vent on top of the pump. Once the heating system is switched on and the fluid heats up it has nowhere to expand and hence the pressure within the sealed system will exceed 3 bar. The boiler has a safety device called a pressure relief valve (PRV – see section above) and this will open to allow sufficient fluid to drain underneath the caravan to return the system pressure to below 3 bar. This operating environment is NOT sustainable and action should be taken to resolve the problem.

The expansion vessel should be re-pressurised or replaced by a Gas Safe engineer. Ensure that the engineer replaces the PRV at the same time as, once used, they have a habit of weeping due to contaminants on the rubber seal. Weeping will slowly reduce the pressure in the sealed system. Also ensure the engineer tests the pressure in the new expansion vessel prior to installation – it should be 1bar/14PSI. If the pressure is low it can be increased using a bicycle pump as the valve is similar to that of a car or bike!

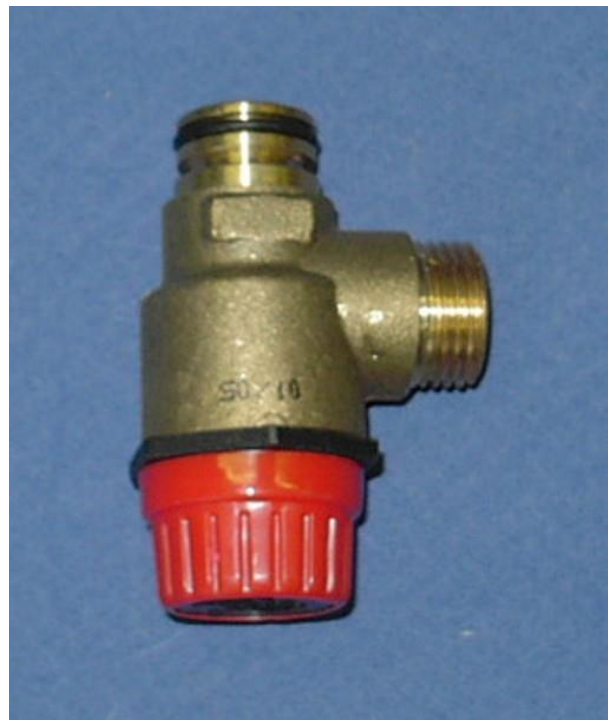
A typical pressure relief valve.

- From the pressure relief valve (PRV). This valve is within the boiler and is connected to the underside of the caravan via an open pipe. This pipe usually runs from the far right hand side of the boiler through the caravan floor. The pipe is designed to be open ended. If the PRV weeps it is visible at the outlet of the pipe and is usually because it has been used as a valve for emptying the boiler prior to some work being carried out. We strongly recommend that all engineers use the drain valve on the bottom of the pump and not the PRV for this purpose. Replacement of the PRV is a job for an engineer.
- Due to the expansion vessel being damaged or faulty – see below
