GB Boiler – Frost Damage Flow Chart

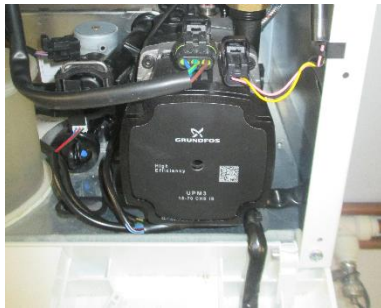
If YES, ensure the pump is black and square as in the below photo

Replacement parts and kits ADP, ADH & ADM

- ICB132002E – Hydroblock
 - ICB121002 – Heat exchanger
 - ICB119001 – Return Group
 - ICB120001 – Flow Group
- #### AFN, AGY & AHN
- ICB132003 – Hydroblock
 - ICB121002 – Heat Exchanger
 - ICB119001 – Return Group
 - ICB120003 – Flow Group

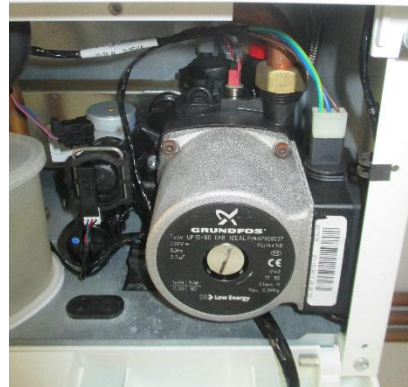
If NO, ensure the pump is grey and round as in the below photo

Replacement parts and kits

- ICB132001 – Hydroblock
- ICB121002 – Heat Exchanger
- ICB119001 – Return Group
- ICB120001 – Flow Group

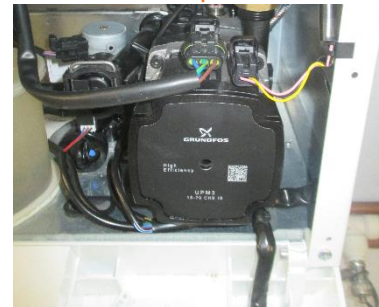
If YES, ensure the pump is black and square as in the below photo

Replacement parts and kits ADP, ADH & ADM

- ICB132302E – Hydroblock
 - ICB121302 – Heat Exchanger
 - ICB119001 – Return Group
 - ICB120001 – Flow Group
- #### AFN, AGY & AHN
- ICB132303 – Hydroblock
 - ICB121302 – Heat Exchanger
 - ICB119001 – Return Group
 - ICB120003 – Flow Group

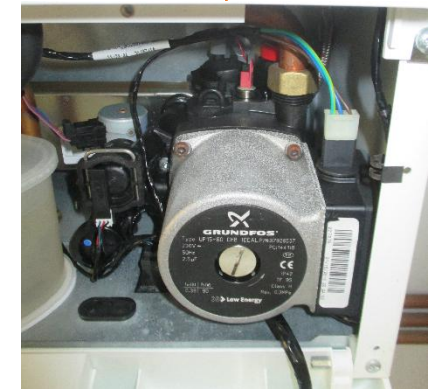
If NO, ensure the pump is grey and round as in the below photo

Replacement parts and kits

- ICB132300 – Hydroblock
- ICB121302 – Heat Exchanger
- ICB119001 – Return Group
- ICB120001 – Flow Group
