FAULT CODE L2 – (Alternating 'L' & '2' – Ignition lock out)

Introduction

There are external factors to the GB24 and GB30 boiler which cause the L2 Fault Code to display and switch the boiler off. This factsheet describes what the external factors are and how an end user can resolve them and restart the boiler.

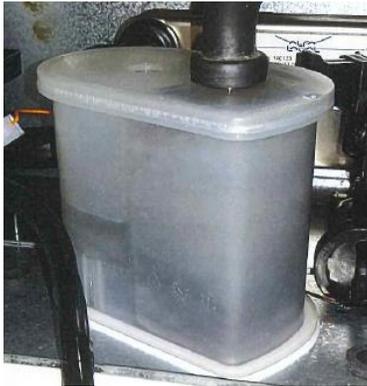
This extinguishes the burner in the boiler and displays a fault code of L2. If your condensate trap looks like the picture below to the left, not like the clean one to the right and / or is making a gurgling noise then there is a strong possibility that this is your problem.

Dirty / blocked condensate trap

Blocked condensate – What to do next?

This problem is not covered under our warranty as we are unable to control the cleanliness of air entering the boiler and the volume of condensate by-product being produced. Our manual advises that the boiler should be serviced at least annually. The frequency of servicing will depend upon the installation condition and usage. During a service the engineer, amongst other things, will remove the burner and clean the whole heat exchanger and condensate path with hot water. This returns the system to a clean state. This is the best guard against a blocked condensate system. It is important to use a Gas Safe Engineer to carry out the service.

To reset boiler, turn the mode control knob (far left hand side on the boiler) to the reset position and immediately turn knob back to required setting. The boiler will repeat the ignition sequence if a heat demand is present. If the boiler still fails to light consult a Gas Safe Registered Engineer, or in other countries a qualified and competent Gas Installer.

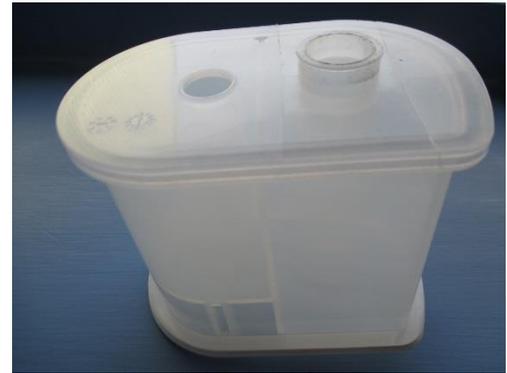
Both the GB24 and GB30 are condensing boilers. In common with all condensing boilers, whilst the boiler is in use a condensate liquid is produced that leaves the boiler via a syphonic condensate trap (as can be seen in the right hand picture) and flows into the waste water drain under the holiday home. In certain circumstances the pathway leading to the condensate trap can become blocked as well as the condensate trap itself. An indication of this occurring is when a gurgling noise is produced from the boiler and the condensate trap becomes discoloured and black.

Clean condensate trap

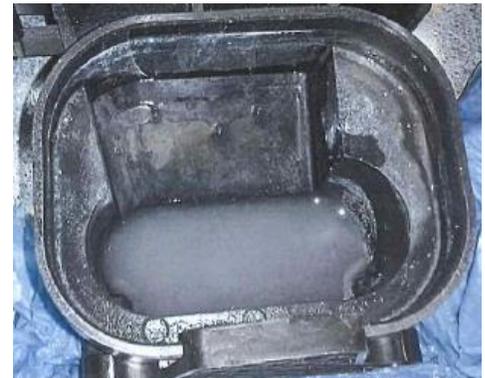
Blockages occur because debris that the boiler breathes in via the flue and the condensate fluid by-product becomes stuck within the pathway leading to the condensate trap. This in turn also blocks the waste pipe and trap. Therefore the boiler cannot remove the condensate liquid and fails to operate which shows fault code L2. The image to the right shows an example of liquid building up from the trap back into the boiler. This may occur more frequently to boilers that are exposed to slightly harsher environments such as salt, sand, dust and leaves from trees.
